JVL
intelligent motors

Troubleshooting guide for MIS and MAC

Instructions for solving common issues

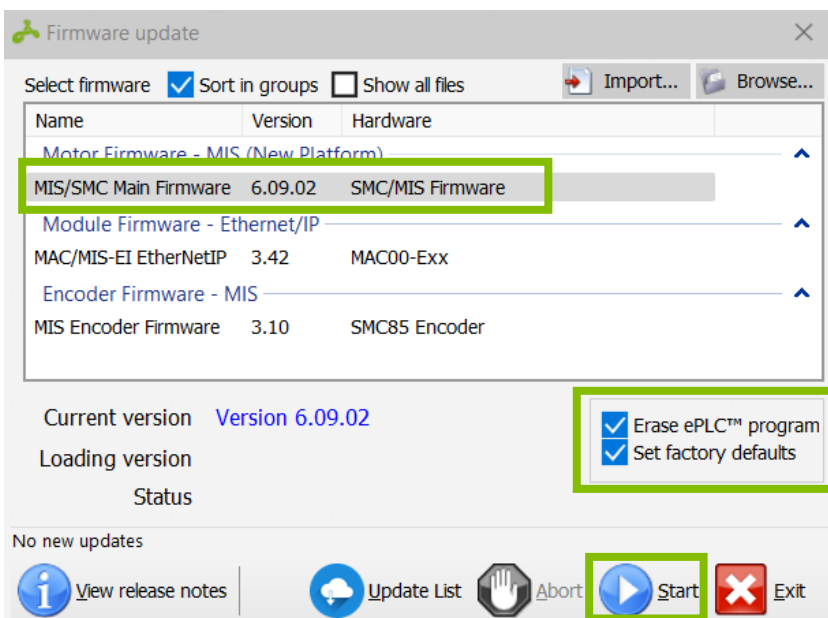
2	Select the correct firmware for your motor type. Note: Check the motor model. If it is incorrect, you can check the “Show all files” option and choose the correct firmware for your motor.

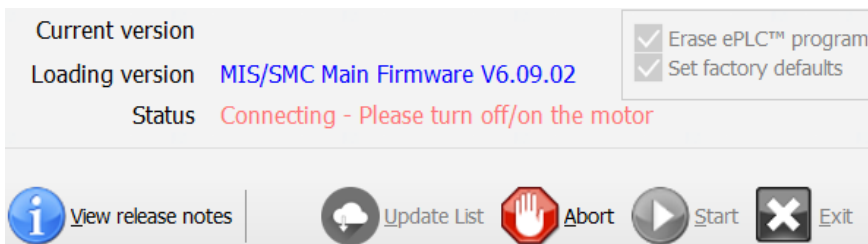
3	Once the pictured status message shows, turn on the 24 VDC supply.

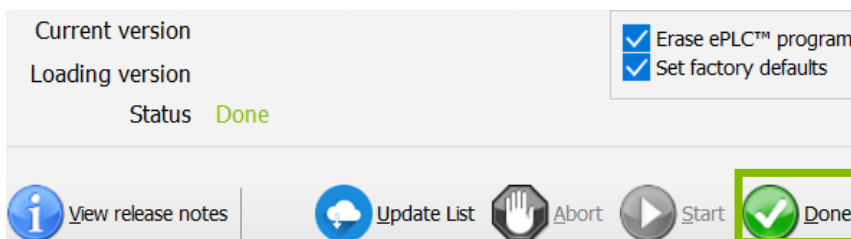
4	Once the update is complete, your motor will be back to default settings. Press “Done”

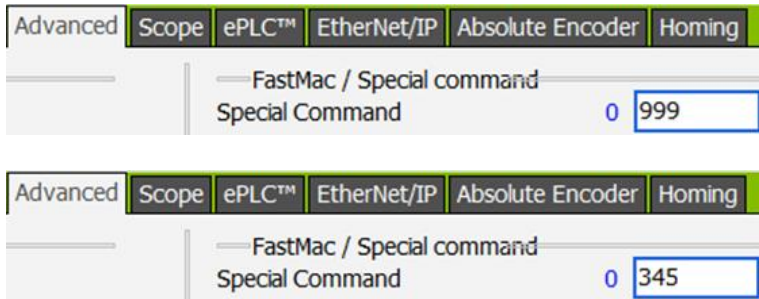
Step	Text	Image
1	<p>Issue command 999 and then 345.</p> <p>To verify that the command has worked, there should be no negative values in the P1/P2 registers.</p>

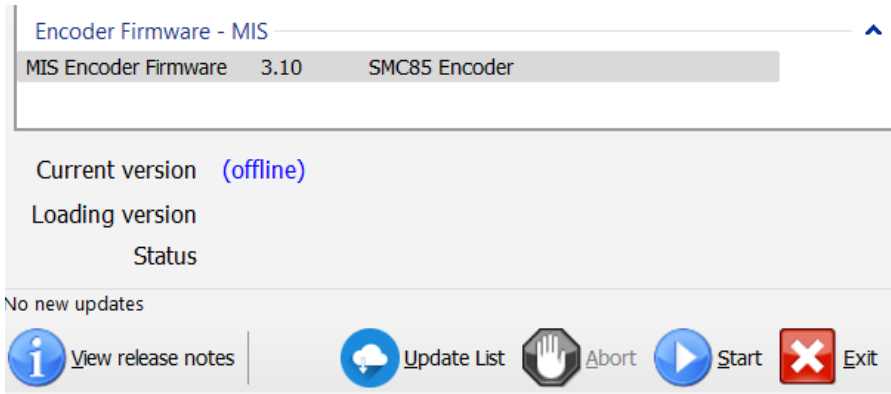
2	<p>Update the encoder to the latest version.</p>

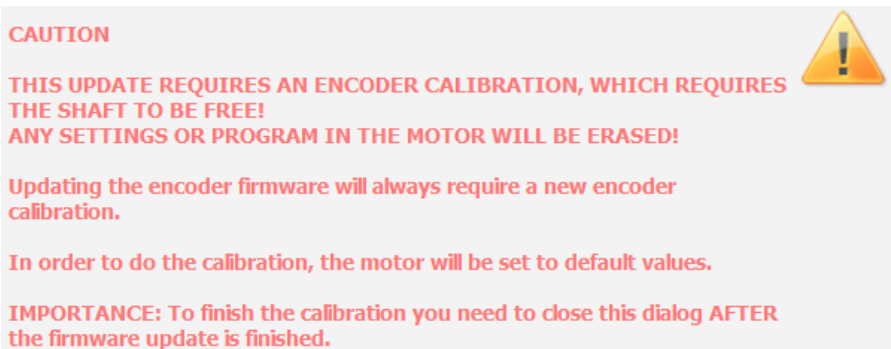
3	<p>The following message will appear. Read it and press "Next".</p> <p>The motor now updates the firmware, performing a factory reset of the motor in the process.</p>

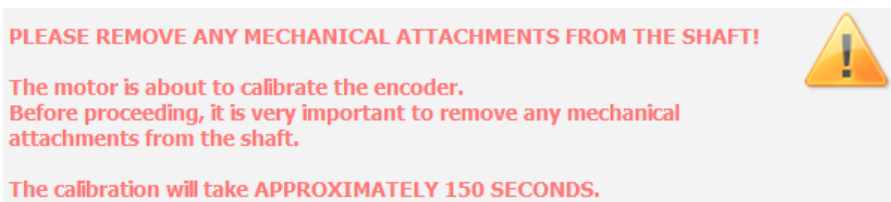
4	<p>After the update is completed, the motor will restart and give you the following message.</p> <p>Press "Next" and wait a few minutes for the auto calibration to finish.</p>
